Appendix B – Supplemental Water Quality Data

Fluvial Geomorphic Assessment of Goodall Brook in Sanford, Maine

Appendix F – List of Priority Structural BMP Retrofits

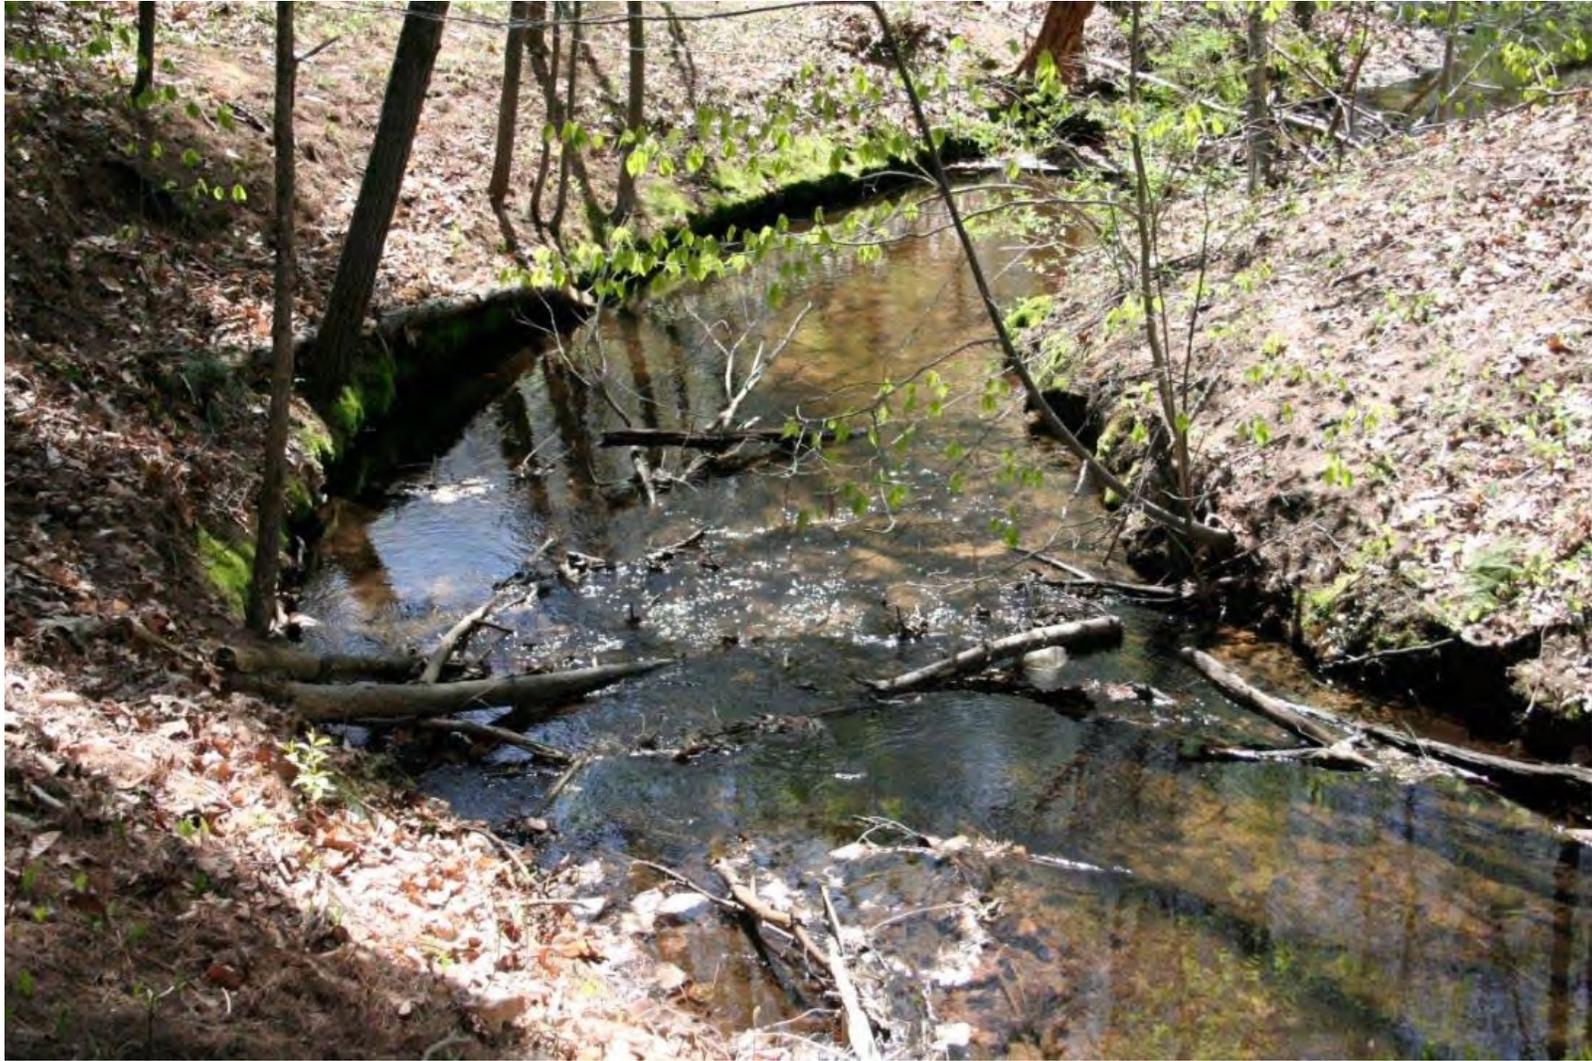
Figure 3. A relatively narrow channel with a sinuous planform characterizes Reach 3.

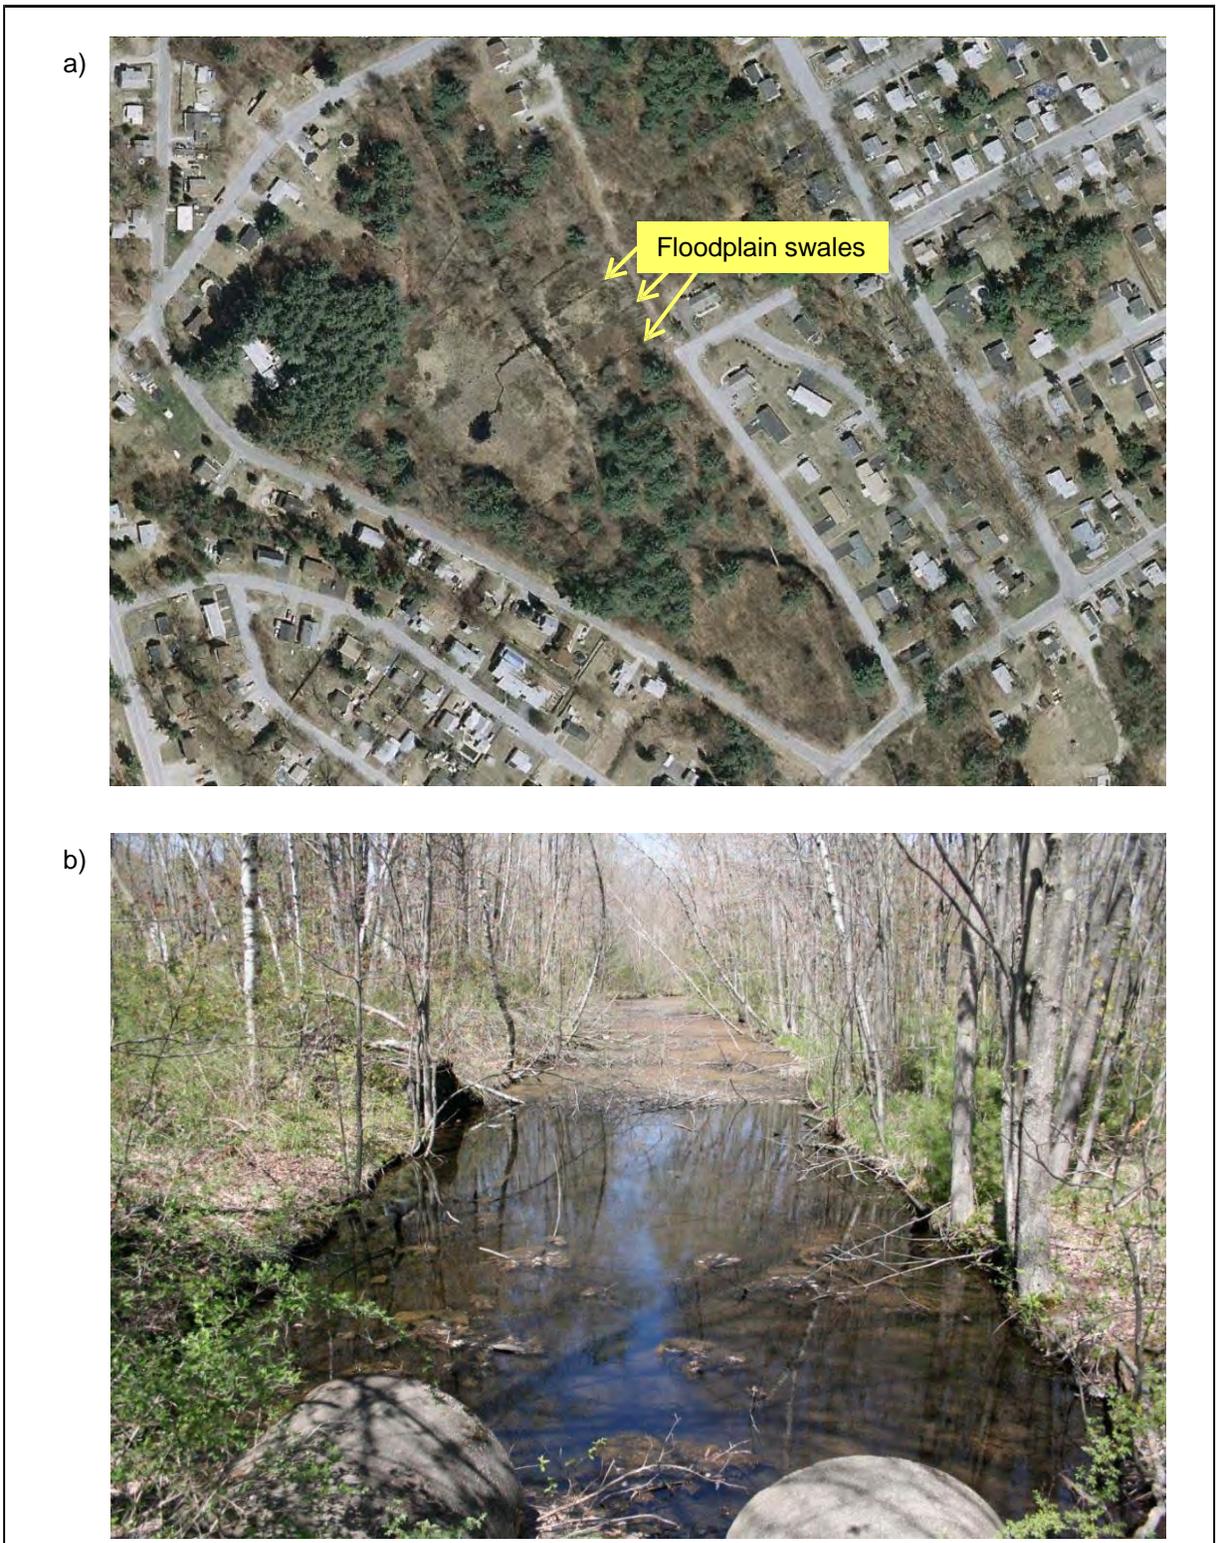
Figure 4. A wide straight channel is typical of Reach 2 as seen on a) aerial photographs and b) ground photographs. Note only some of the parallel floodplain drainage swales are highlighted on aerial photo.

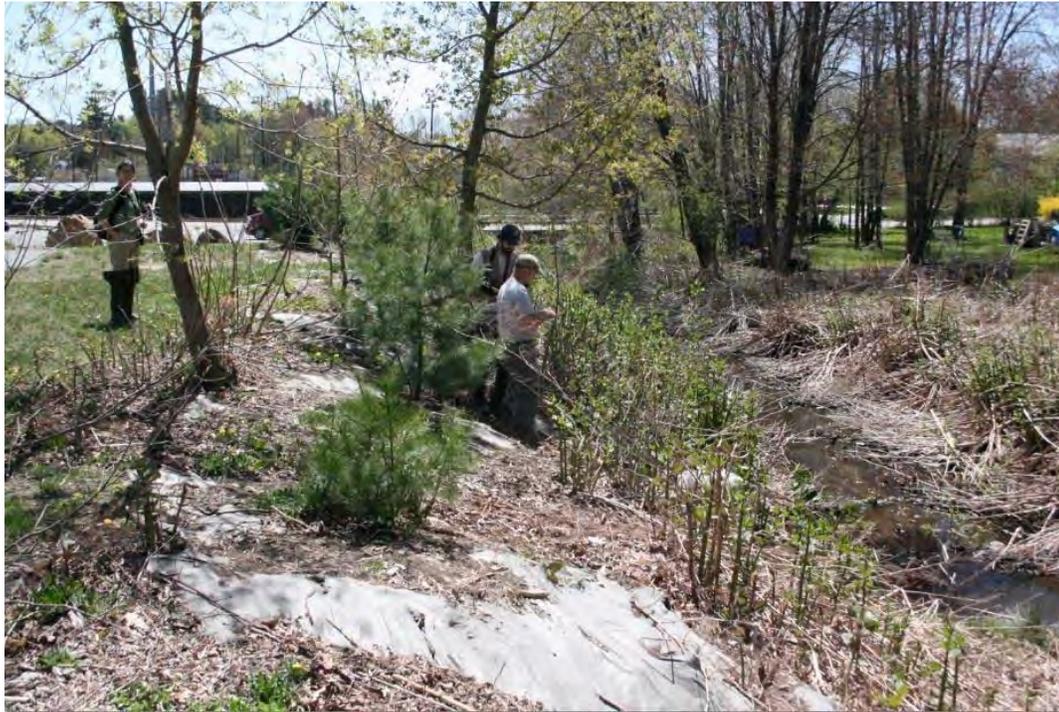
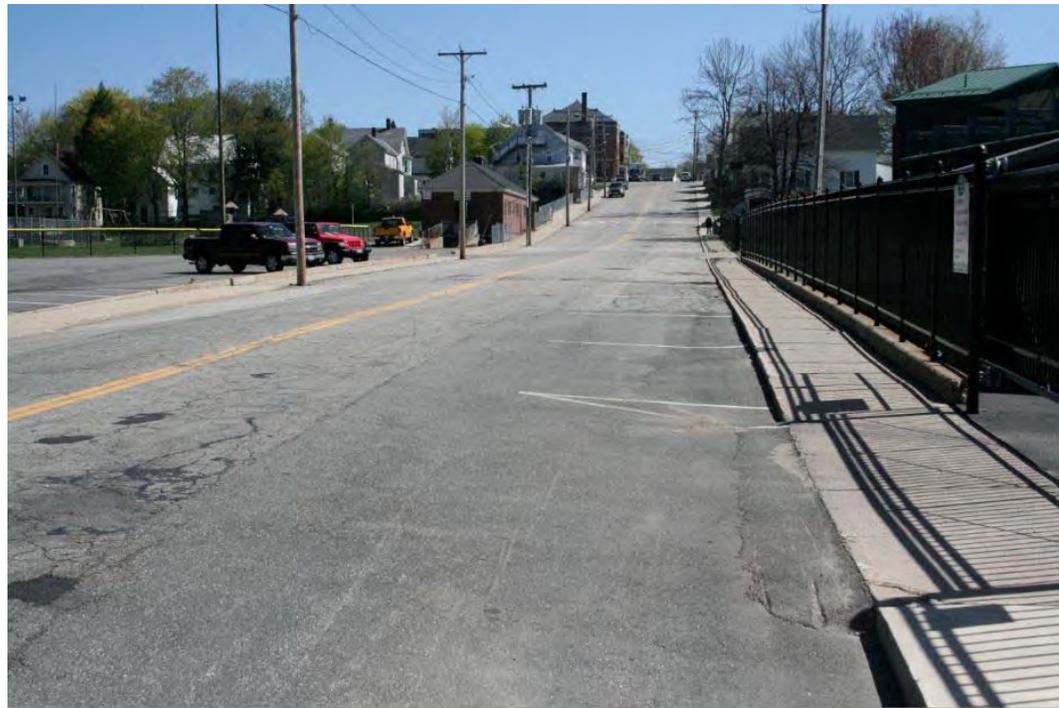
While the straightened channel throughout most of Reach 2 has very low banks (less than 2 ft high), one or both banks along portions of Reach 1, particularly the left bank (looking downstream) at Goodall Park, are 5 ft or higher (Figure 5a). These banks may be artificially high due to the placement of floodplain fill at Goodall Park between the channel and the higher glaciogenic surface on which Town Hall rests (Figure 5b). If true, the parking area shown in Figure 5b and the ball park rest on artificial fill with the original unaltered lower floodplain surface still present on the right bank (Figure 5a). Archival information available for this study is not sufficient to confirm whether artificial fill was placed in this area in the past, but such documentation may be available in town records or a local historical society. The narrowing of the floodplain resulting from the placement of artificial fill on the left bank would increase flow velocities in the channel and on the lower floodplain surface on the right bank (Figure 5a) and may be why scour is observed along the right bank across from the ball park (Figure 6).

Figure 5. At Goodall Park the a) high banks on the left bank compared to the right bank may be due to b) the placement of artificial fill between the channel and higher surface on which Sanford Town Hall is built.

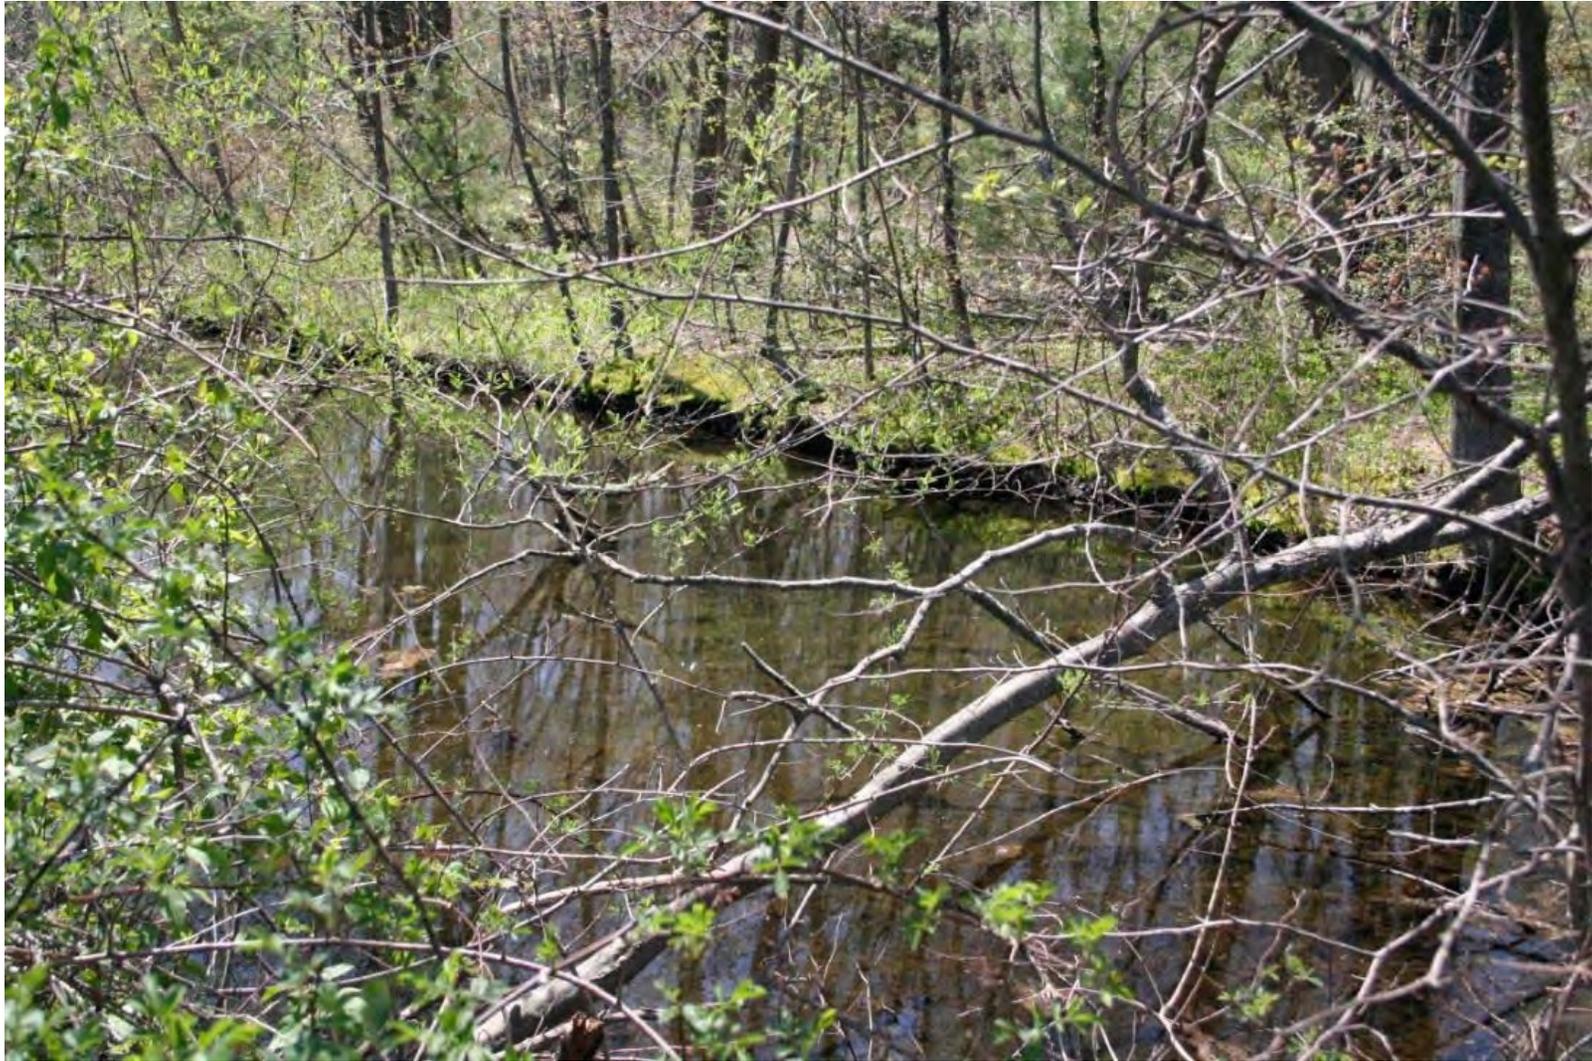
Figure 6. Bank scour on the right bank across from the Goodall Park ball field may be associated with artificial fill placed on the left bank floodplain.

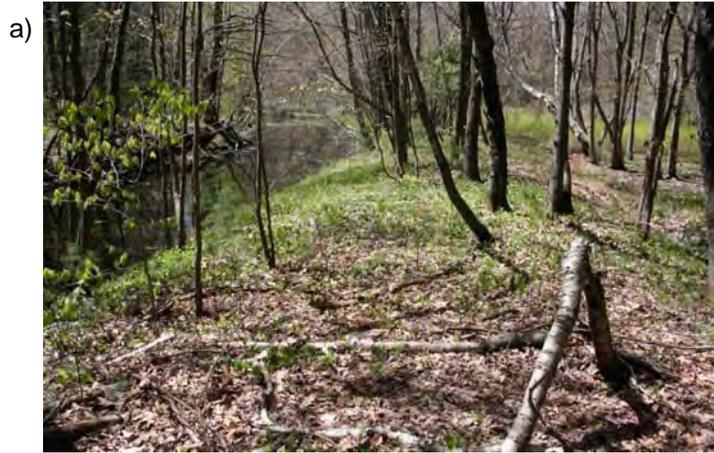
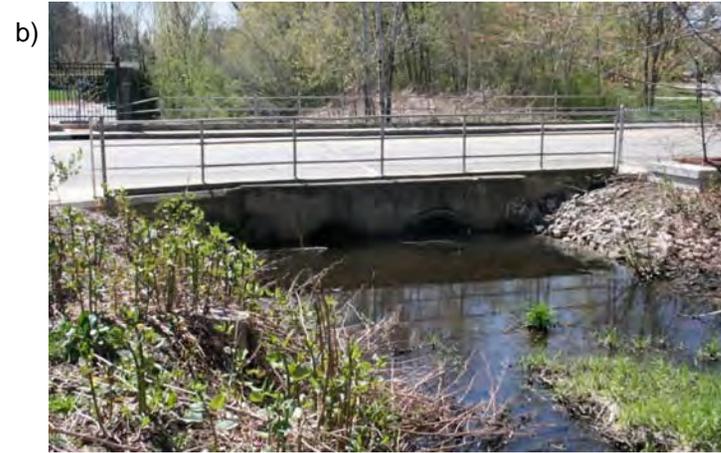
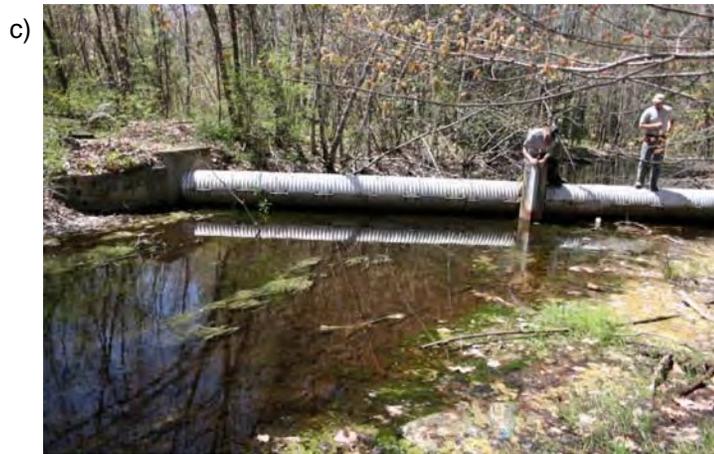
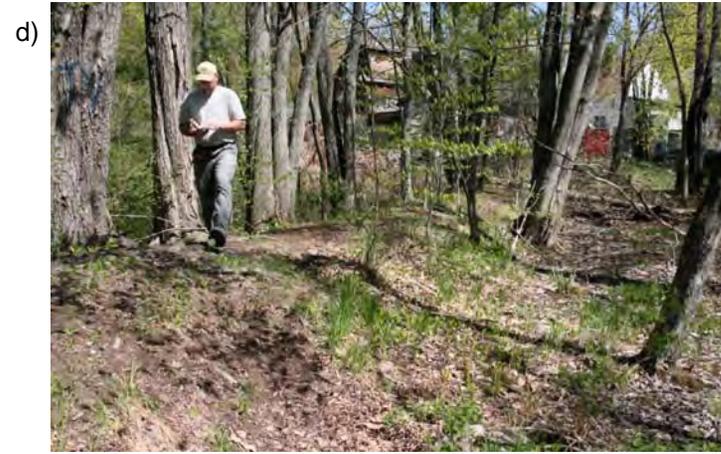
In addition to the floodplain fill, Reaches 1 and 2 are constrained in a number of other ways. The floodplain fill at Goodall Park may also have extended into and further constrained the channel, explaining, at least in part, why the channel is much narrower in Reach 1 (Figure 5a) than in the straightened channel downstream (Figure 4b). The “Goodall Brook Channel Improvement” plan calls for material removed from the channel to be disposed of largely along the edge of the channel to create berms that are observed today along portions of Reach 2. As a consequence, floodwaters are unable to access portions of the floodplain at bankfull discharge. The exact location and height of berms was not determined as part of this study, so the degree to which floodplain connectivity has been compromised is unknown. In other areas, a sewer line and other structures paralleling the channel act similarly to berms by further blocking floodplain access (Figure 7a).

At least 4 culverts, all with openings narrower than the channel’s width, cross the stream channel (Figures 2 and 7b), leading to stagnant flow conditions upstream. Fine sediment deposits in the channel are locally more than 2.0 ft thick (before a harder substrate is encountered at depth) with the culverts at least partially responsible for this deposition. While scour pools often form downstream of culverts, none were observed along Goodall Brook due to limited stream power in the low gradient system and perhaps due to backwatering from the next downstream culvert. A sewer pipe runs across the channel in at least one location (near the downstream end of Reach 2), impounds flow during higher discharges, and has caused deposition along the margins of the channel both upstream and downstream (Figure 7c). This has caused a narrowing of the low flow channel, although the bankfull width remains largely unaltered. Similar deposition and channel narrowing has occurred where trees have fallen in the channel (Figure 8), creating short lengths where flow is visibly moving in an area otherwise characterized by stagnant low flow conditions. Near the upstream end of Reach 1, the remnants of an old earthen dam block most of the floodplain (Figure 7d). The channel is split into multiple flow paths upstream of the former dam, but a single flow path is present where the channel has breached the dam and continues as a single flow path downstream. The various channel constraints present on Goodall Brook (Figure 7) alter flow conditions in a variety of ways to cause deposition, bank erosion, and complex flow patterns.

Figure 7. Channel constraints on Goddall Brook include: a) berms and other structures paralleling the channel and blocking the floodplain; b) culverts, c) sewer pipes, and d) remnants of an earthen dam.

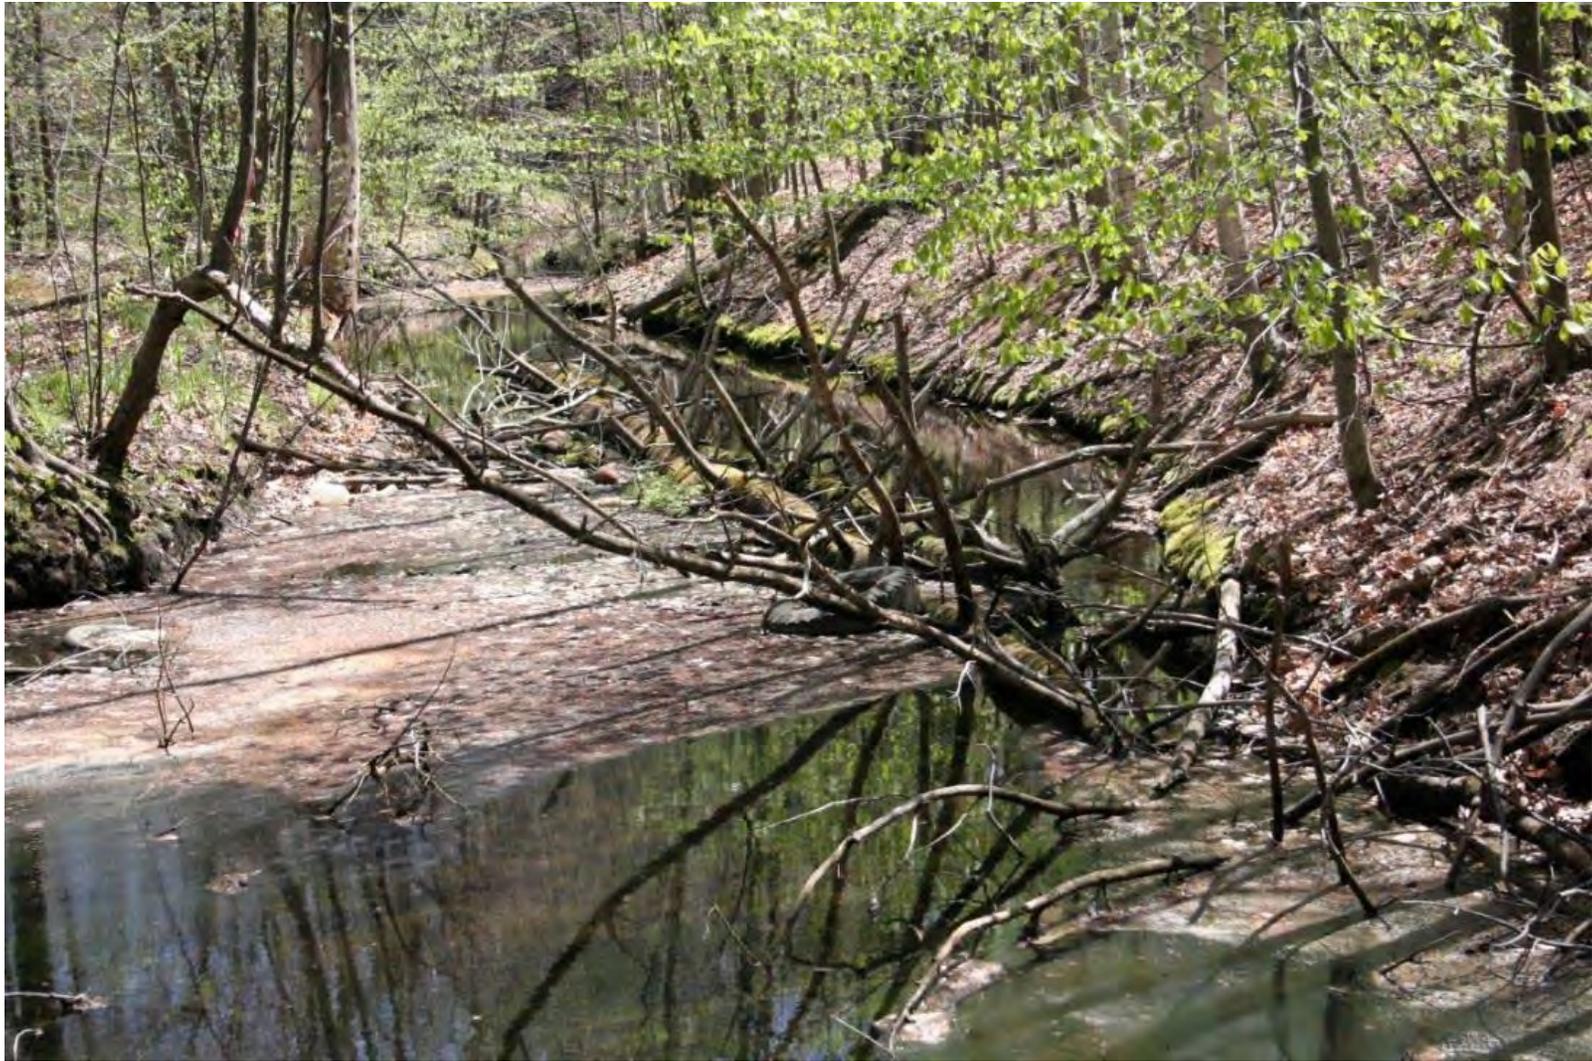
Deposition, channel narrowing, and flow complexity developed around wood that has naturally fallen into the channel suggests that the construction of marginal log jams along the straightened and overwidened channel could be valuable in restoring natural channel dimensions and sinuosity. However, complete restoration of geomorphic and ecological function would depend on floodplain reconnection and would further require the partial removal of berms and resizing of culverts. Additional studies are needed to corroborate the findings of this initial assessment of geomorphic conditions on Goodall Brook and to further develop restoration plans. Such studies should include: 1) topographic surveying of channel dimensions and floodplain features; 2) detailed mapping of channel constraints such as berms; 3) archival research and sedimentological descriptions of test pits to confirm the presence of floodplain fill; and 4) hydraulic modeling to identify the most appropriate culverts and other channel constraints to resize or remove in order to maximize the restoration of natural flow patterns at minimal cost. These additional studies will be critical in developing a sound management plan for restoring natural geomorphic function, and in turn, for achieving the sustainable habitat improvements necessary for Goodall Brook to meet state water quality standards.

Figure 8. Deposition and channel narrowing is associated with wood that has fallen into the channel.

The restoration of more natural conditions, whereby a narrower more sinuous channel is flowing through a wide marshy floodplain, could be partially achieved through wood additions in the channel. The use of marginal log jams alternating on different sides of the channel would encourage narrowing of the channel, lead to less stagnant flow, and develop a more sinuous flow path. Natural wood accumulating in the channel (Figure 8) provides an analogue of how constructed log jams would respond in the channel. More comprehensive restoration attempting to fully reconnect the channel and floodplain, would also have to consider berm removal, infilling of floodplain drainage swales, replacement of culverts with stream crossings that reduce flow impoundment in the channel and on the floodplain, and, where practicable, removal of artificial fill on the floodplain. The slow episodic process of natural meander reformation that would be encouraged by wood additions and removal of channel and floodplain constraints is as important to the restoration of geomorphic function and habitat complexity as the final fully meandering equilibrium condition that would develop over time. Consequently, imposing constructed meanders on the system as part of a more active, and expensive, restoration plan is not recommended.

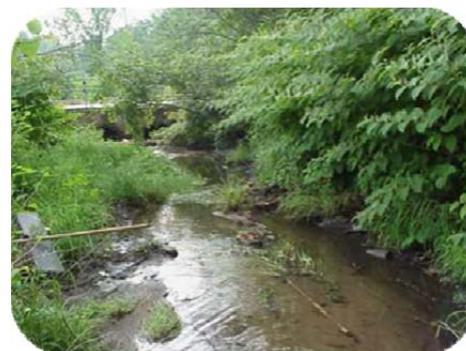
Goodall Brook downstream of Station 747. (Photo: DEP Biomonitoring Program)

Goodall Brook starts in the most built out area of Sanford and follows through dense development for nearly its entire course. This development, especially in the form of impervious cover, has a negative impact on the stream. The impervious cover TMDL assessment for Goodall Brook addresses the probable impairments to aquatic life uses (benthic macro-invertebrate and stream habitat assessments). These impairments are associated with a variety of pollutants in urban stormwater as well as erosion, habitat loss and unstable stream banks caused by excessive amounts of runoff.
