Appendix B – Supplemental Water Quality Data

Fluvial Geomorphic Assessment of Goodall Brook in Sanford, Maine

Appendix F – List of Priority Structural BMP Retrofits

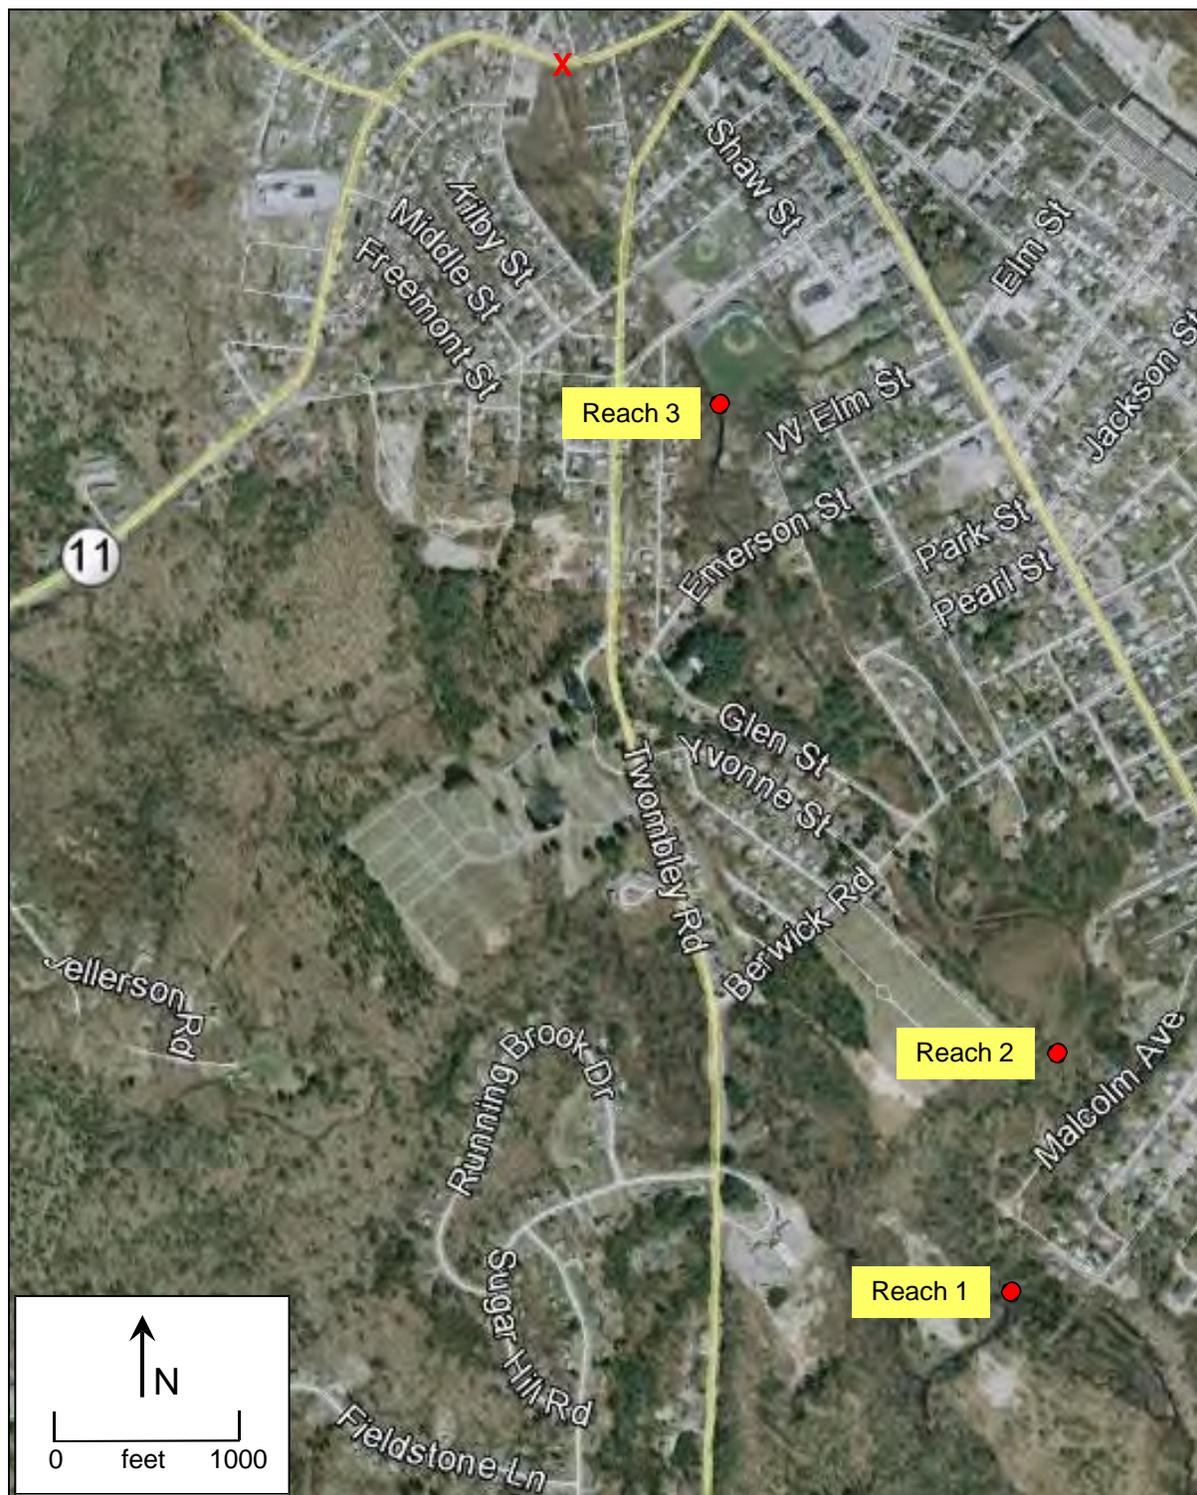
Goodall Brook was subdivided into 3 reaches of uneven length from the upstream end of the northern branch to the Kennebec River confluence (Figure 2). The upstream most reach, Reach 1, extends from Lebanon Street (Route 11/202) at the upstream end to the downstream end of Goodall Park (i.e., ballpark) just downstream of Roberts Street. The downstream end of Reach 2 is where Malcom Avenue approaches the brook and Reach 3 extends to the confluence with the Great Works River. Only the upper portion of Reach 3 was assessed, so conditions may vary closer to the Great Works River confluence. Currently, the channel in Reaches 1 and 3 are relatively narrow with some sinuosity (Figure 3) in comparison to the much wider and straighter Reach 2 (Figure 4). The narrowness and sinuosity of Reach 3 is due to natural confinement by (what are likely) glaciogenic deposits, while Reach 1 conditions are likely altered by human influences (see below). Reach 2 has a very wide floodplain as did Reach 1 prior to human alteration. The gradient in Reach 2 is very low, suggesting that under natural conditions with high wood loadings that this reach (and possibly Reach 1 as well) was, at least in part, marshy with a poorly defined channel. The earliest topographic map

Figure 2. Location of reaches on Goodall Brook. Note that labeled points are at downstream end of given reach with red "x" representing upstream end of channel.
